Manhole Inspection Summary

Manhole # S21C__036MH

Insp Date: **10/17/07 11:30 AM**

Location Address: **1902 LAURETTA-FRANKLIN**

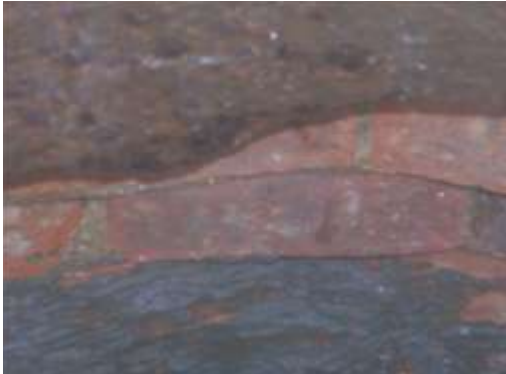
Defect 3

Comments **frame is broken where it meets chimney**

Frame Offset: **0** (in.) Condition: ☐ Sound ☒ **Cracked** ☐ Leaks

BROKEN FRAME

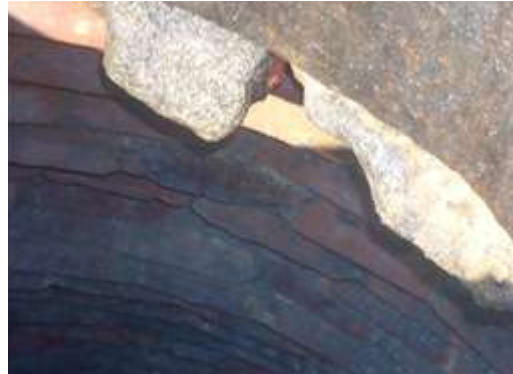
Defect 2

Condition: ☐ Sound ☐ Cracked ☐ Root Intrusion ☒ **Loose Brick** ☐ Deteriorated

LOOSE CHIMNEY STONES and
deteriorated

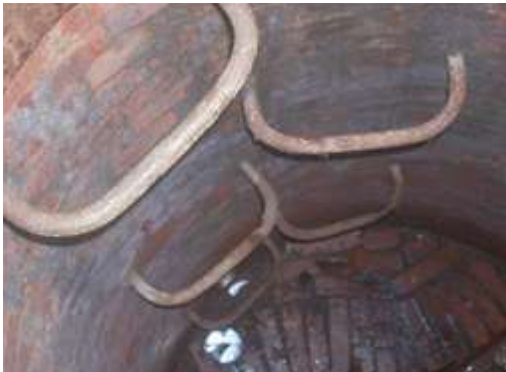
Defect 1

Steps Count: **5** Missing: **0** ☒ **Corroded**

CORRODED STEPS

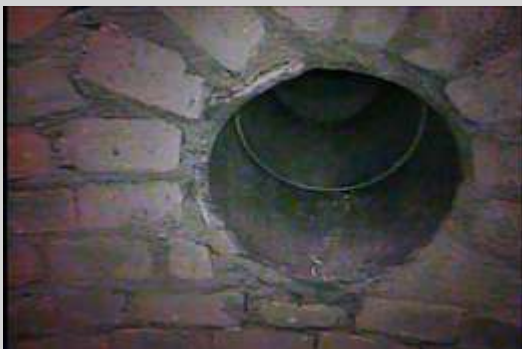
3 O'Clock Inflow

Pipe Height: **7.2** (in.) Rod and Bar (Angled)
Pipe Material: **Clay** ☐ Pipe Lined
Invert Depth: **5.92** (ft.) Flow Characteristics: **Slow**
Deposits: ☒ None ☐ Mud ☐ Sludge ☐ Debris ☐ Grease
Silt Depth: (in.) Deposits Extent:
Infiltration: **None** Pipe Seal Cond: **Broken**

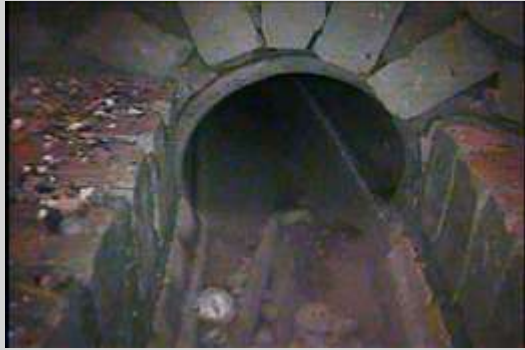
6 O'Clock Inflow

Deposits: ☐ None ☐ Mud ☐ Sludge ☒ **Debris** ☐ Grease

Silt Depth: **2** (in.) Deposits Extent: **Light**
